**Amendment 39-18171; AD 2015-11-08]**

**Airworthiness Directives; Agusta S.p.A. (Agusta) Helicopters**

2015-11-08 **Agusta S.p.A. Helicopters (Agusta)**: Docket No. FAA-2015-1937; Amendment 39-18171, Directorate Identifier 2014-SW-067-AD.

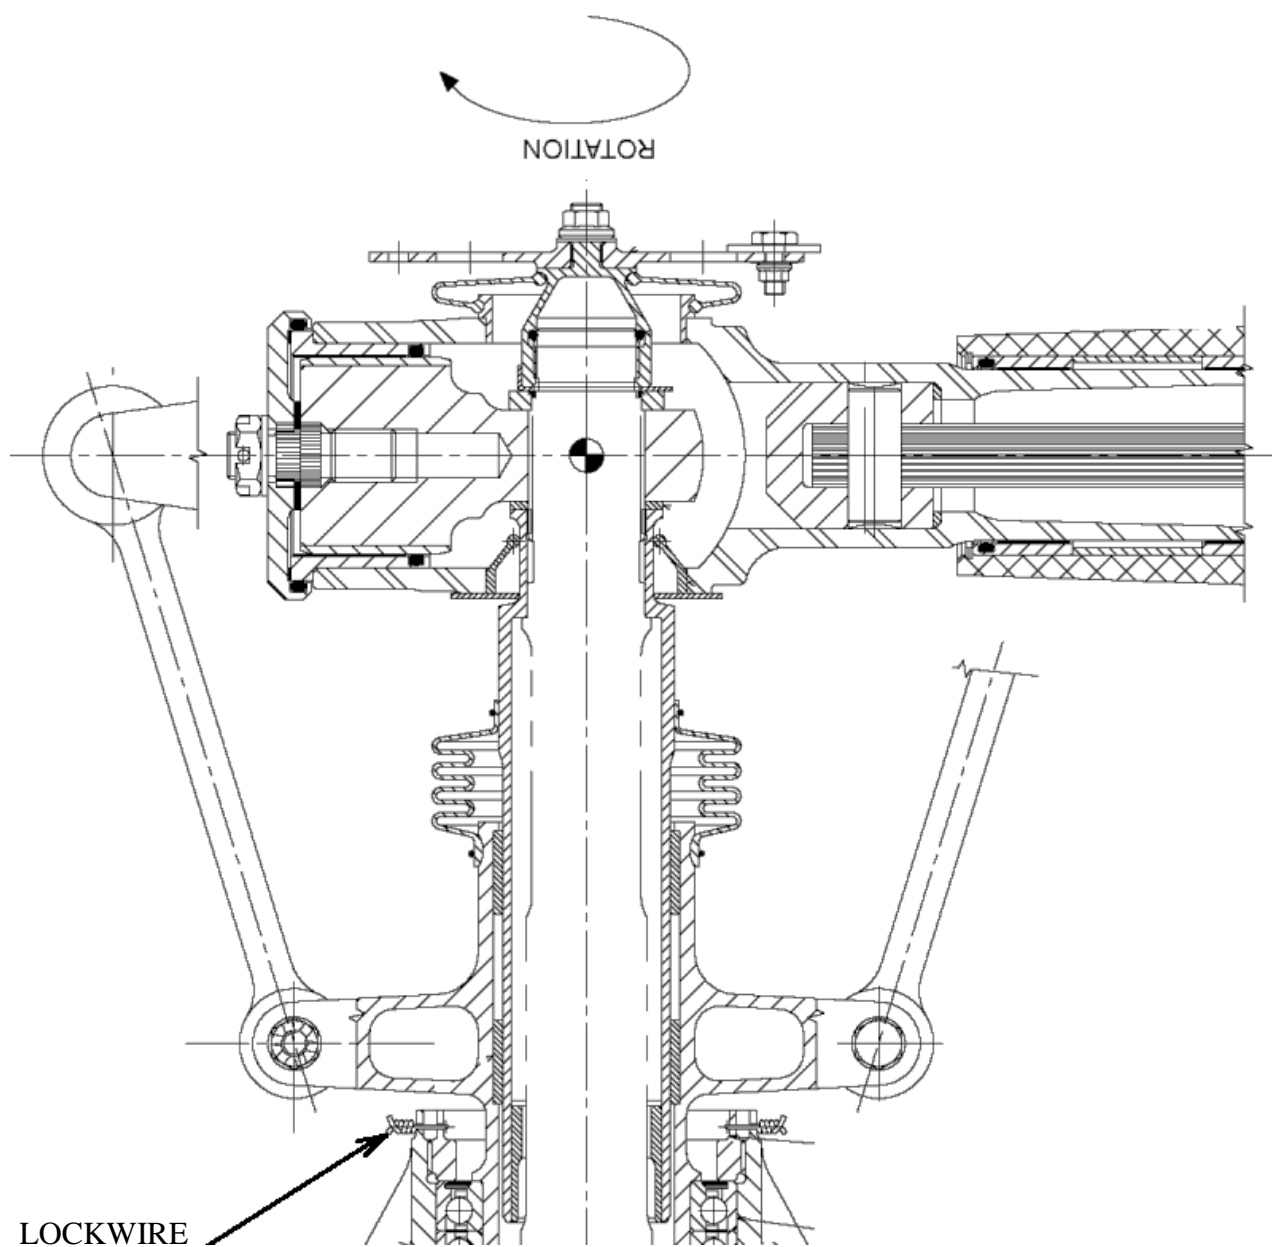
**Figure 1 of paragraph (f)(1)**

This AD defines the unsafe condition as a missing or broken lock wire securing the tail rotor (T/R) duplex bearing locking nut (locking nut). This condition could result in loosening of the locking nut, failure of the T/R, and subsequent loss of control of the helicopter.

(1) Within 24 hours and thereafter before the first flight of each day or at intervals not exceeding 24 hours, whichever occurs later, check each lock wire securing the T/R locking nut to the housing. The location of the housing wire is depicted in Figure 1 to paragraph (f)(1) of this AD.

(4) If one or both lock wires are missing or damaged, before further flight, remove and reassemble the housing and slider group of the T/R rotating controls.
